Tracking Vapor Intrusion Pathways – an Active Tracer Gas Test

Per Loll (pl@dmr.dk), Poul Larsen and Claus Larsen (DMR A/S, Denmark)

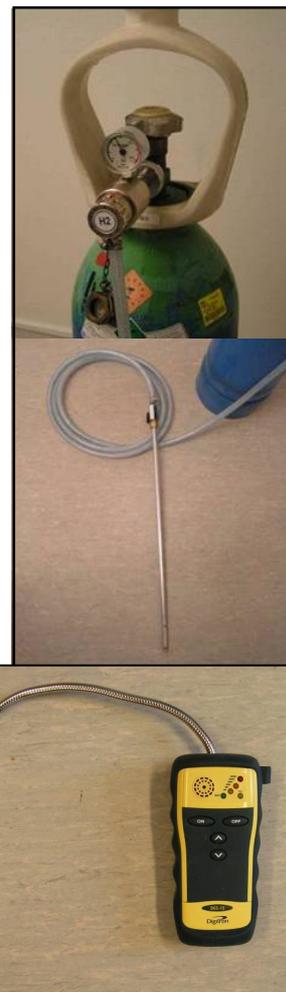
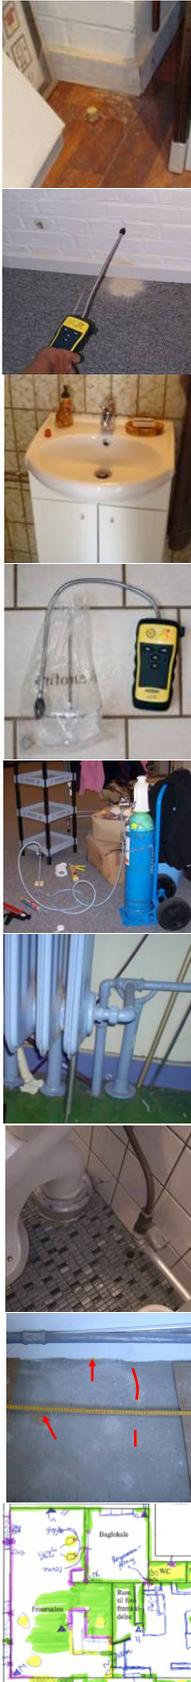
1. Establishment of an injection point (IP) by drilling an \varnothing 14 mm hole through the concrete slab. The IP should be placed in an area where the soil vapor is assumed to contribute to the indoor air, e.g. in the hot-spot. Often times, previous sampling points can be used. Installation of the injection rod with connection to the sub slab soil gas phase. Teflon tape and an acrylic sealant are used to seal around the injection point.

The tracer gas is released through an adjustable valve (either 0.5-5 L/min or 1-15 L/min) and a flexible tube mounted on an aluminum rod via a Ballofix valve. The rod is the type we use for soil gas sampling (\varnothing 12 mm outer diameter). For this application we have shortened it to approximately 40 cm length. Between the rod and the concrete slab we use Teflon tape and applied acrylic sealant.
